DEPARTMENT OF TRANSPORTATION**DIVISION OF ENGINEERING SERVICES**

Contract #: 04-0120F4Cty: SF/ALA Rte: 80 PM: 13.2/13.9File #: 69.28**WELDING INSPECTION REPORT****Resident Engineer:** Pursell, Gary**Address:** 333 Burma Road**City:** Oakland, CA 94607**Report No:** WIR-001944**Date Inspected:** 27-Mar-2008**Project Name:** SAS Superstructure**OSM Arrival Time:** 630**Prime Contractor:** American Bridge/Fluor Enterprises, a JV**OSM Departure Time:** 1730**Contractor:** Zhenhua Port Machinery Company, Ltd (ZPMC), Changxing Island **Location:** Shanghai, China**CWI Name:** See below**CWI Present:** Yes No**Inspected CWI report:** Yes No N/A**Rod Oven in Use:** Yes No N/A**Electrode to specification:** Yes No N/A**Weld Procedures Followed:** Yes No N/A**Qualified Welders:** Yes No N/A**Verified Joint Fit-up:** Yes No N/A**Approved Drawings:** Yes No N/A**Approved WPS:** Yes No N/A**Delayed / Cancelled:** Yes No N/A**Bridge No:** 34-0006**Component:** OBG/Tower**Summary of Items Observed:**

OBG/Tower Sub Assembly**Bay 7-OBG - Floor Beam Sub Assembly:**

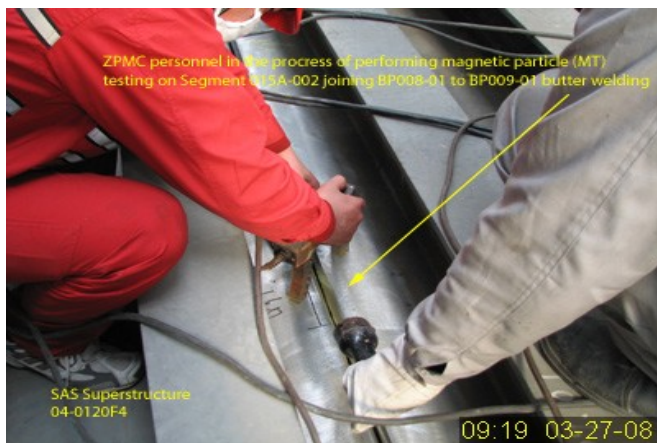
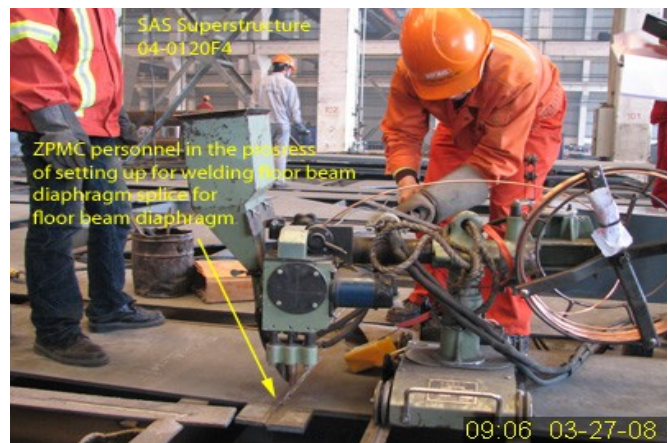
The following digital photograph below illustrates observation of the activities being performed.
